Manhole Inspection Summary

Manhole # S67O__003MH

Location Address: **6500 Boston St.**

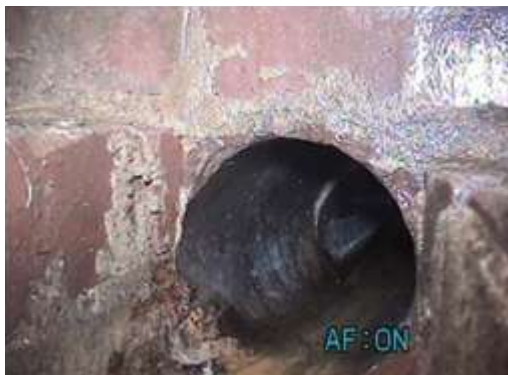
Defect 2

9 oclock incoming pipe connection--[dae]
deposit attach encrustation 6 to the 9

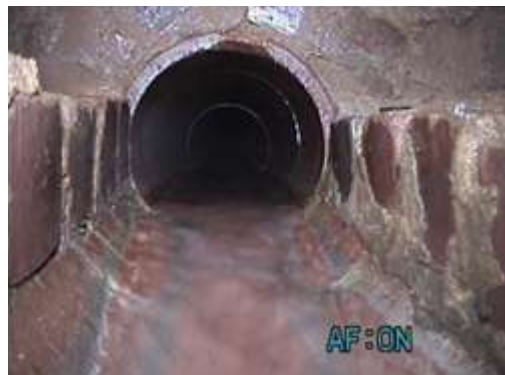
Defect 1

6 oclock incoming pipe---broken from the
12 to the 1

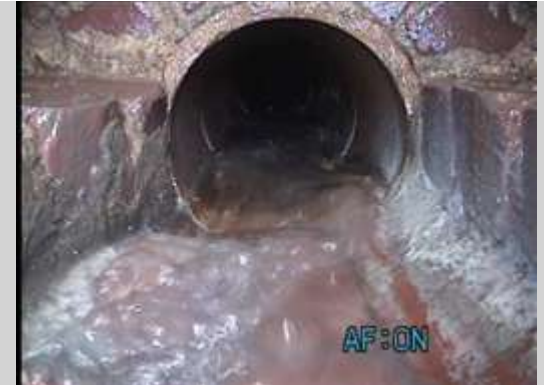
12 O'Clock Outflow

Pipe Height: **8.4** (in.) Rod and Bar (Angled)
Pipe Material: **Clay** ☐ Pipe Lined
Invert Depth: **6.58** (ft.) Flow Characteristics: **Fast**
Deposits: ☒ None ☐ **Mud** ☐ Sludge ☐ Debris ☐ Grease
Silt Depth: (in.) Deposits Extent:
Infiltration: **None** Pipe Seal Cond: **Sound**

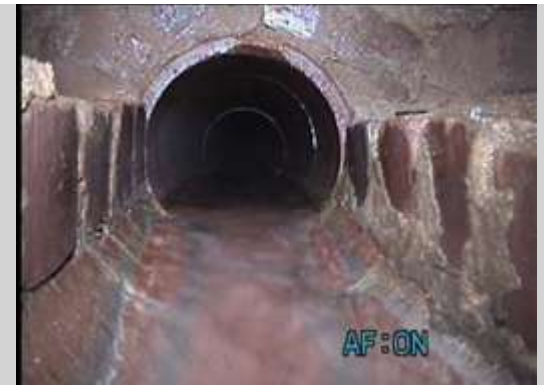
6 O'Clock Inflow

Pipe Height: **8.4** (in.) Rod and Bar (Angled)
Pipe Material: **Clay** ☐ Pipe Lined
Invert Depth: **6.50** (ft.) Flow Characteristics: **Fast**
Deposits: ☒ None ☐ **Mud** ☐ Sludge ☐ Debris ☐ Grease
Silt Depth: (in.) Deposits Extent:
Infiltration: **None** Pipe Seal Cond: **Sound**

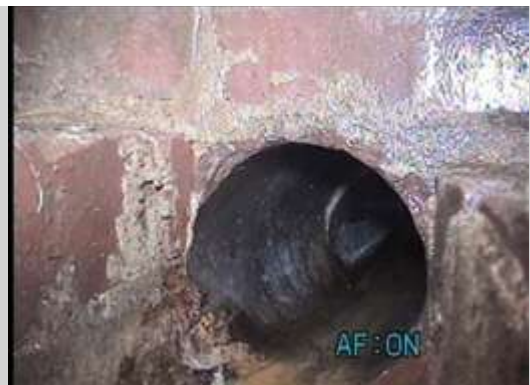
9 O'Clock Inflow

Deposits: ☐ None ☒ **Mud** ☐ Sludge ☐ Debris ☐ Grease

Silt Depth: **0.25** (in.) Deposits Extent: **Light**
